Manhole Inspection Summary

Manhole # S15EE1033MH

Location Address: **2443 SHIRLEY AVE**

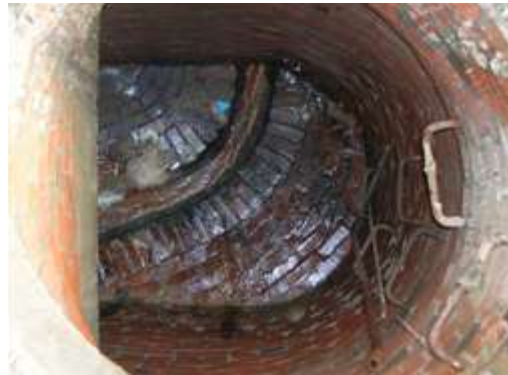
Top View

Corroded steps. Evidence of surcharge - Bench debris.

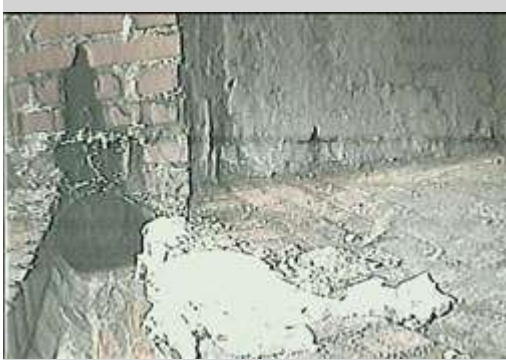
Defect

Barrel infiltration. (Active)

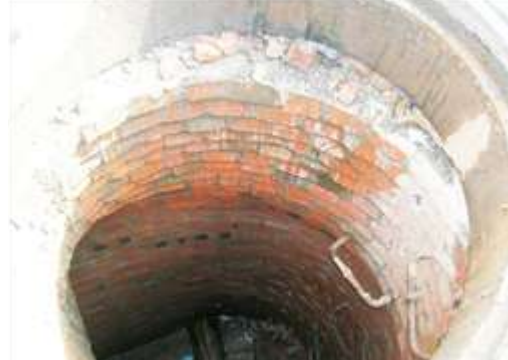
Defect

Frame leaks. Frame offset. Adjustment deterioration, loose brick and infiltration. Corbel and Barrel infiltration.

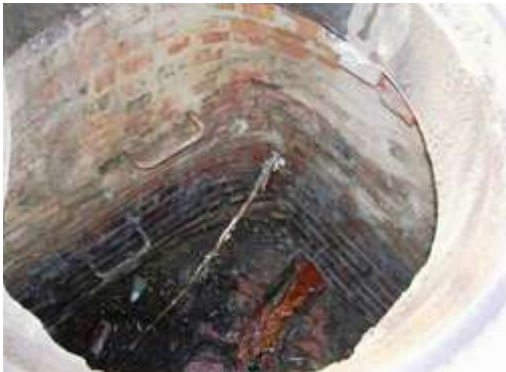
Defect

Frame leaks. Frame offset. Adjustment deterioration, loose brick and infiltration. Corbel and Barrel infiltration. - other side.

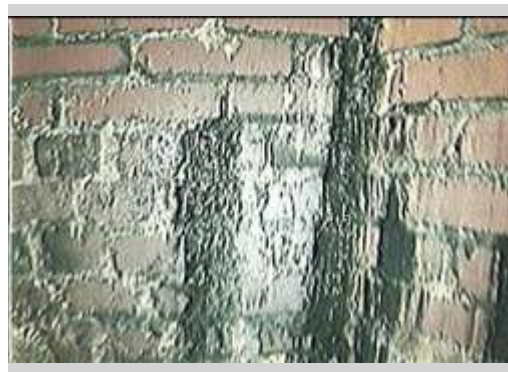
Defect

Barrel deterioration and infiltration.

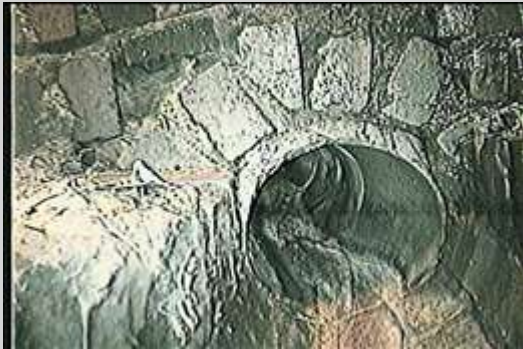
8 in. Circular Gravity Sewer Pipe Out @ 12 O'Clock

Infiltration: **Evidence**

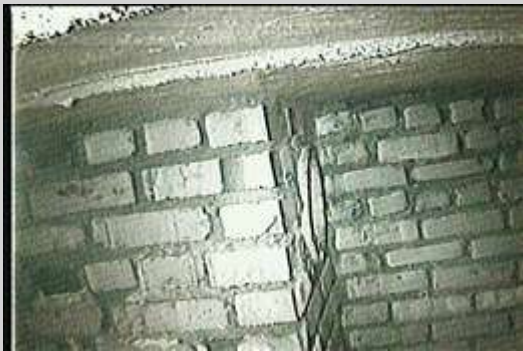
8 in. Circular Gravity Sewer Pipe In @ 7 O'Clock

Infiltration: **Evidence**
